## New Robotic Inspection Technology Helps ID Potentially Critical Situation

Early this year, water officials in Toronto, ON, Canada, became aware there were cracks in one of the city's primary large-diameter sanitary sewer trunk mains that threatened the Don River watershed and homes in one neighborhood. A potentially disastrous impact on the area and its environment could develop if the aging 114-inch pipe should become blocked or collapse.

The three-mile long Coxwell Sanitary Trunk Sewer, described as the city's most critical trunk sewer section, was built in the 1950s and serves 750,000 residents typically carrying more than 105 million gallons of sewage per day to the Ashbridges Bay treatment plant.

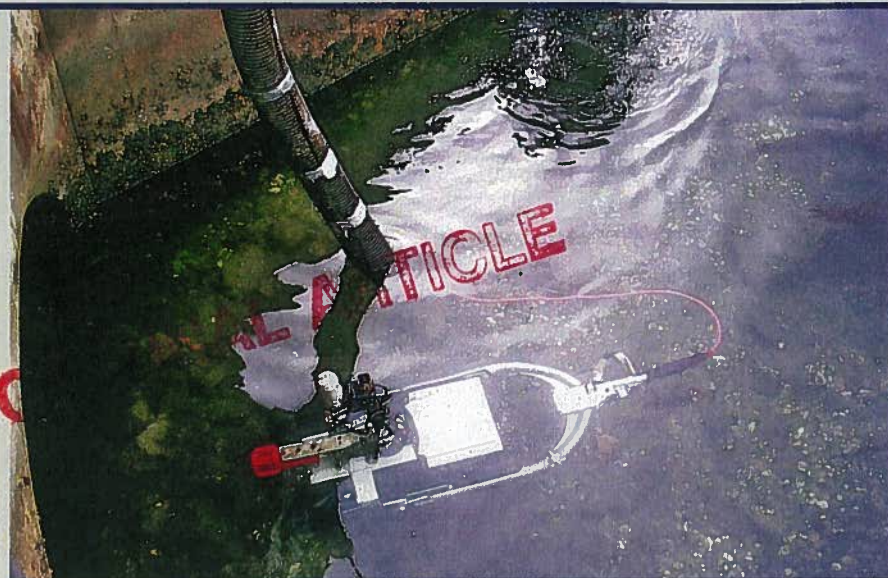
Brousseau said the unique RedZone Robot is equipped with multiple sensors, including a traditional pan and tilt closed-circuit television camera, sonar for seeing below the water line, three-dimensional laser for measuring pipe ovality and precise

surface abnormalities, hydrogen sulfide sensor, inertial measurement unit for line and grade, and water depth sensor. All sensors record continuously and are synchronized over the pay-out distance.

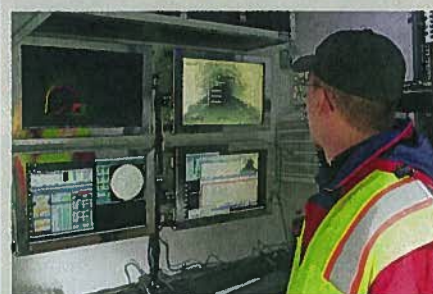
The robot weighs about 650 pounds and has a 6,500-foot-long, high-strength tether with embedded fiber-optic cable. The robot's mast can be lowered or raised to keep

the 3D laser and camera out of the water for optimum visual observations and precise profiling of the inner pipe wall.

The robot is designed to fit through a standard manhole opening. It is lowered by a power winch to the base of the manhole. Once in the pipe, it is remotely controlled from a truck by the tether with a fiber optic, hydraulic and electric power cord with high a high-strength external protective sheath. The robot moves on twin, independently-powered tracks that permits it to traverse debris and turn around inside the pipe. The equipment normally is operated by a crew of three.
